Q Downtown Elevated - North, Town of - 01/09/2019

Inspection Detail Downtown Elevated - North, Town of - 01/09/2019

Tank Name Downtown Elevated

Inspection Date 01/09/2019

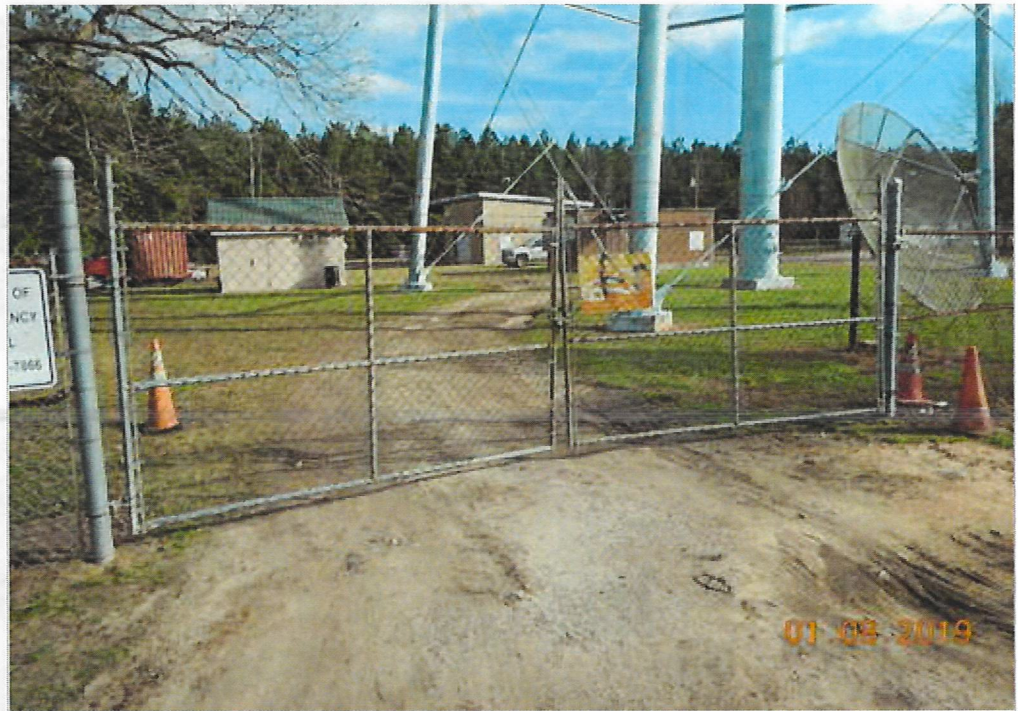
Site Access
Picture

Site Accessibility

Compliant

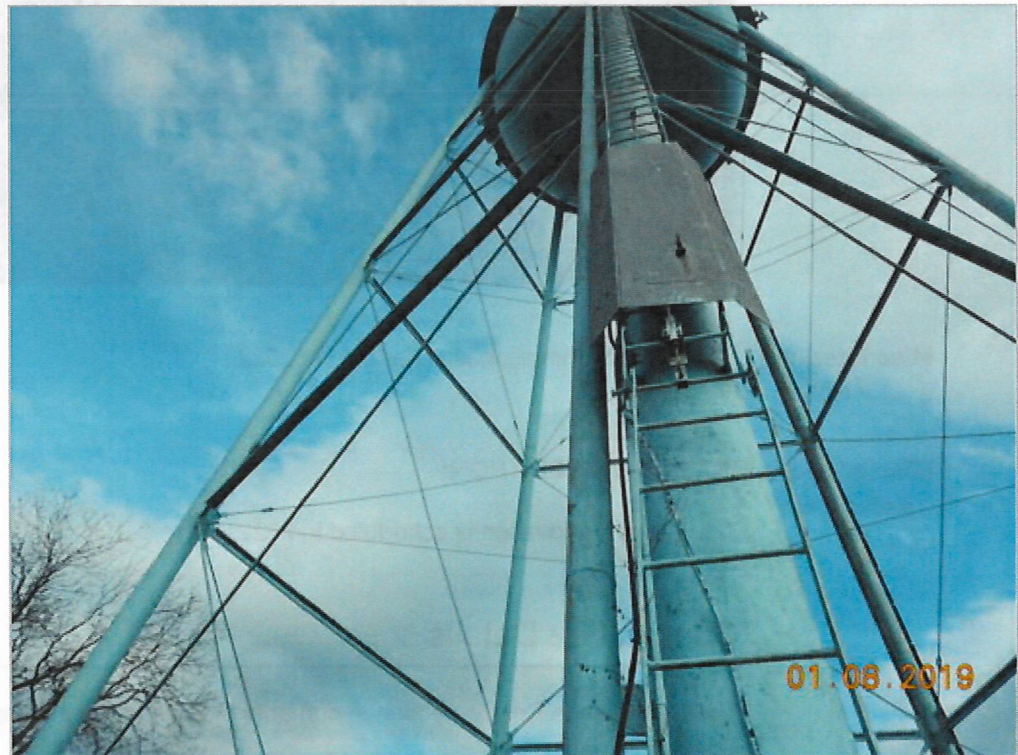
Trespass
Protection
Picture

Trespass
Prevention

Compliant

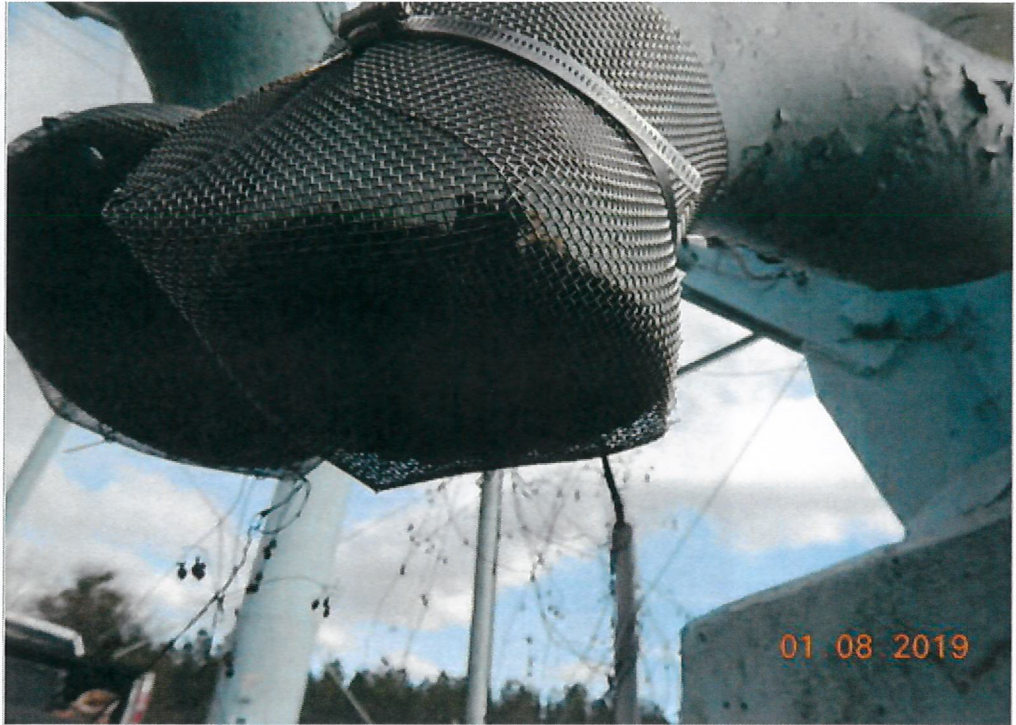
Overflow Pipe
Picture

Overflow Pipe /
Termination

Compliant

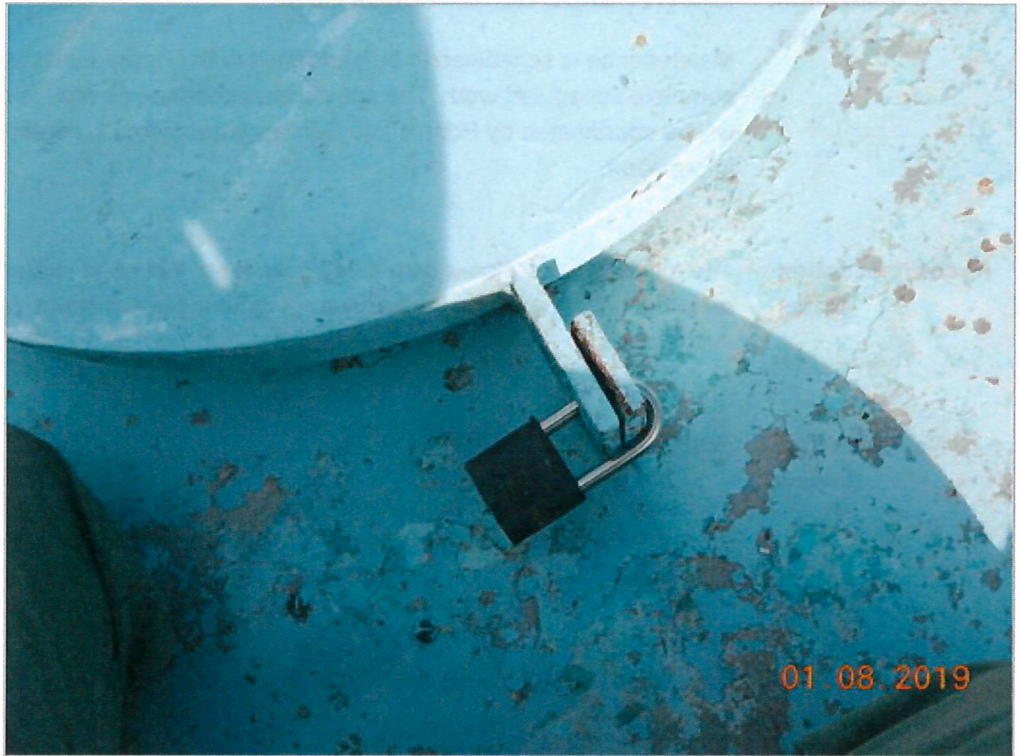
Access Hatch
Picture

Access Hatch /
Lock

Compliant

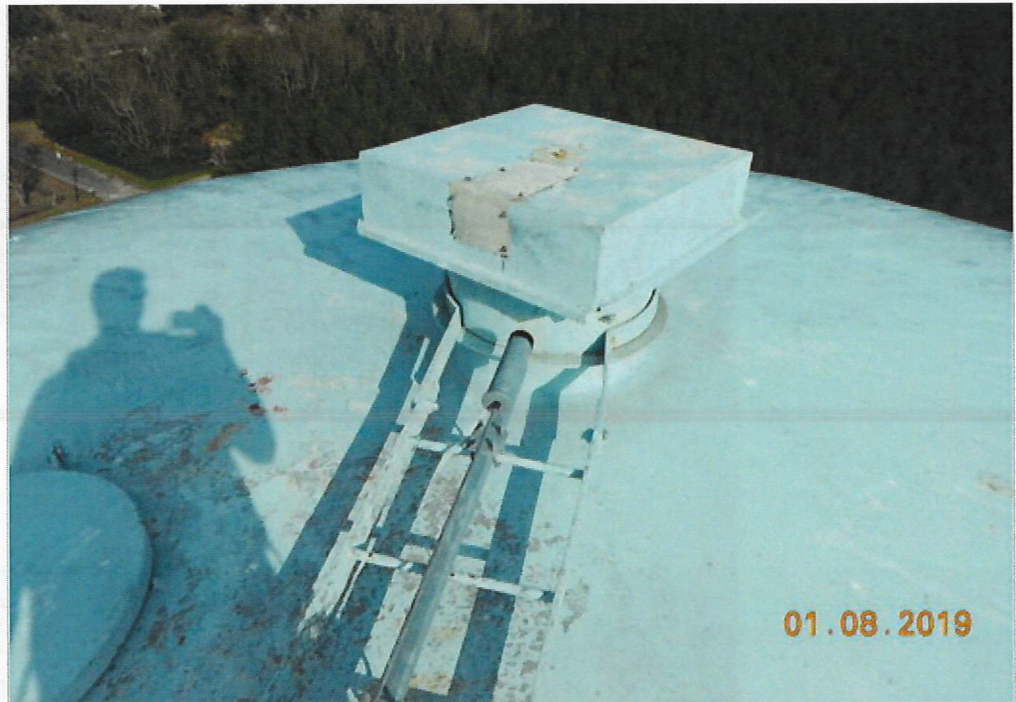
Vent Picture

Venting / Screen

Compliant
